STUDY #1 IN A SERIES OF REPORTS ON RADON IN BC HOMES

## A Comparison of Three Radon Systems in British Columbia Homes:

**CONCLUSIONS AND RECOMMENDATIONS FOR THE BRITISH COLUMBIA BUILDING CODE**

**OCTOBER 2014**

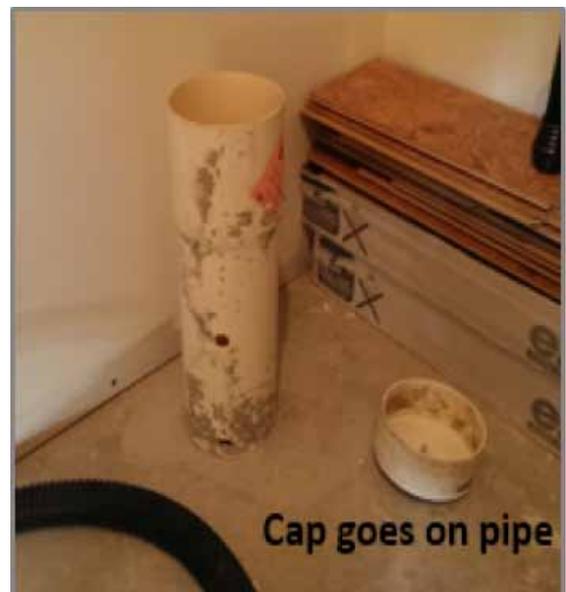
While this home was identified as meeting the year of construction criteria it clearly was not compliant with the 2012 Code in several ways:

- The rough-in pipe had not been capped by the home builder and simply left on the floor, and this situation was not observed during final inspection by the Code compliance authority.
- The radon pipe was perforated. Even if the cap had been placed the perforations in the pipe allowed radon entry into the home.
- The cost of fixing this issue and then making extensive internal alterations to install a passive pipe system through finished space to the roof would have been prohibitive.

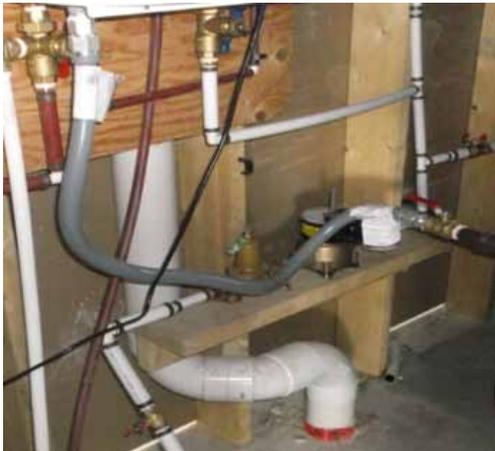
Figure 1. Example of Pipe Not Labeled

In 15 of 16 homes the radon pipe was not clearly labelled (Figure 1).

**Issue** - Residents may not identify the radon pipe's function. This could lead to improper use.

**Solution** - Apply a Radon Pipe Warning label (Figure 2).

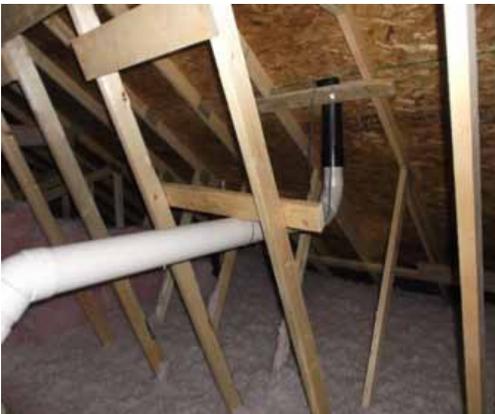
Figure 3. Example of Uninsulated Pipe

In all homes the radon pipe was not insulated in unconditioned spaces (Figure 3).

**Issue** - System may not work to maximum efficiency if pipe is not insulated in an unconditioned space and condensation may form in the pipe.

**Solution** - Insulate the radon pipe all the way through to the roof (Figure 4).

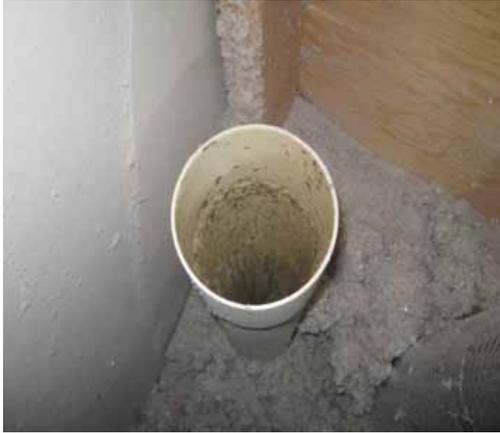
Figure 5. Example of Pipe Venting Into Attic

In 2 of 16 homes the radon pipe was venting into the attic (Figure 5).

**Issue** - Radon venting into attic increases risk of radon levels in living space, condensation may form on the pipe and affect insulation and water on ceiling, and mold may establish in attic space.

**Solution** - Ensure radon pipe is vented out the roof (Figure 6).

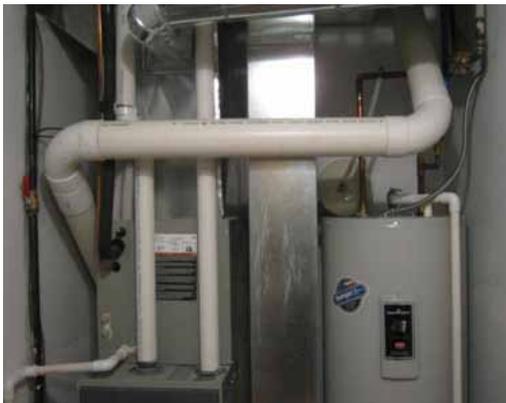
Figure 7. Example of Pipe Run Unsupported

In 6 of 16 homes horizontal runs of the radon pipe were unsupported (Figure 7).

**Issue** - Radon pipe could bend, move, or become unattached.

**Solution** - Provide adequate bracing along the horizontal runs of pipe (Figure 8).

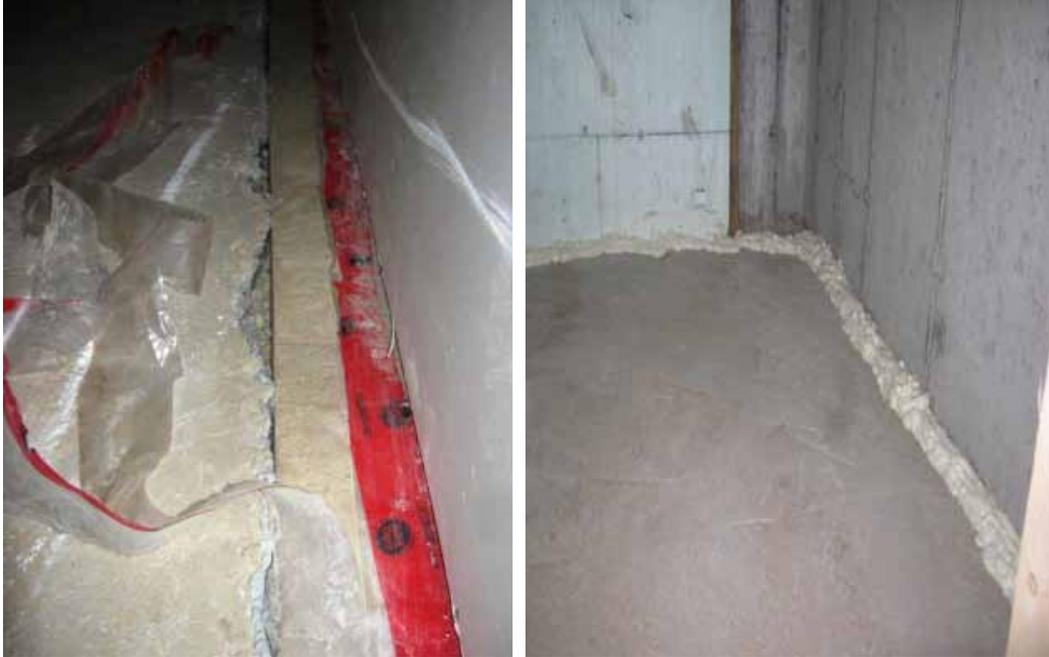
Figure 9. Example of Inadequate Sealing of Slab Edges Figure 10. Example of Slab Edges Sealed with Spray Foam

More than half of homes had inadequate sealing in the slab-floor and edges (Figure 9).

**Issue** - Slab floor cracks, rough edges, and open gaps can be a point of radon ingress.

**Solution** - Ensure proper sealing of all edges, cracks and openings in slab floor (Figure 10).

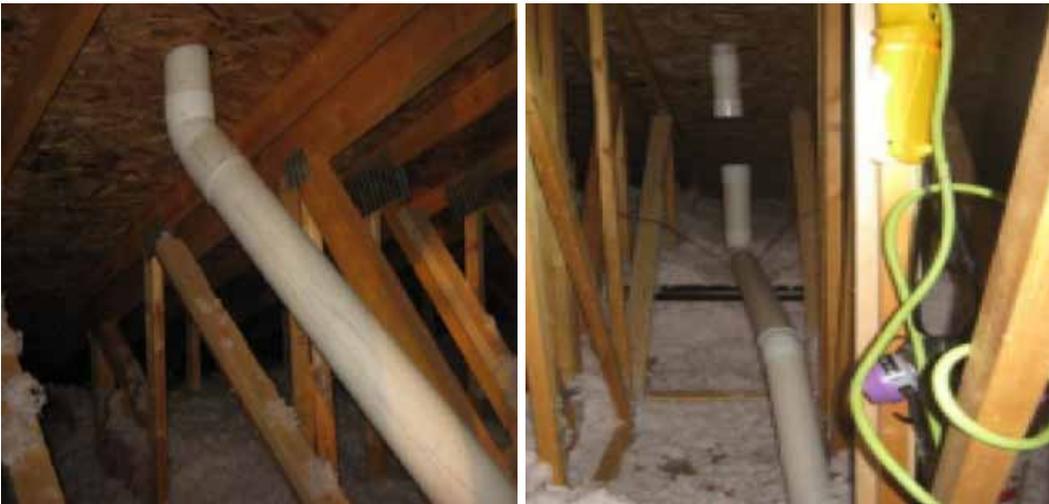
Figure 11. Example of Radon Pipe Positioned on Angle Figure 12. Example of Radon Pipe Cut and Straightened

In 2 of 16 homes the radon pipe was positioned in the attic on an angle (Figure 11).

**Issue** - A radon fan installed to a radon pipe on an angle may get moisture pooling in the fan casing. This will impact the efficacy of the radon fan.

**Solution** - Ensure that the radon pipe exiting the attic is completely vertical (Figure 12).

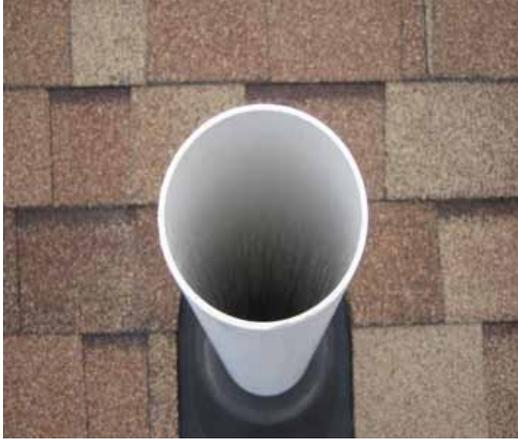
Figure 13. Example of Radon Pipe End with No Screen

In all 16 homes the radon pipe exiting the roof was unscreened (Figure 13).

**Issue** - Debris may fall into the pipe and block the flow.

**Solution** - Insert a screen onto the end point of the radon pipe (Figure 14).

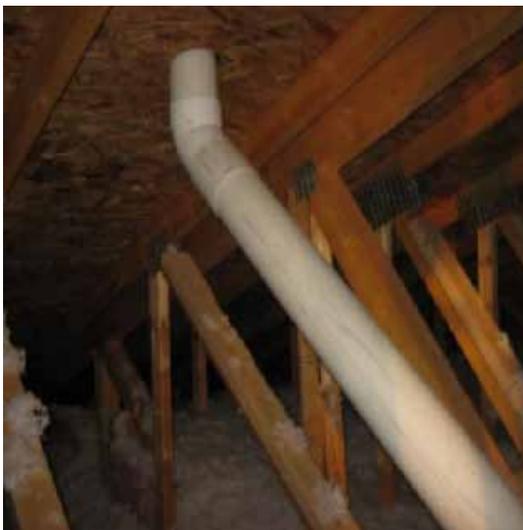
Figure 15. Example of Passive Pipe with No Electrical Provisions

More than half of homes required installation of electrical provisions near the radon pipe in the attic (Figure 15).

**Issue** - Installing an added electrical connection in the attic at the same time as a Passive System install can substantially reduce costs for future application of an Active Radon Reduction System.

**Solution** - Install an electrical connection during Passive System install (Figure 16).
