RADON AWARE CASE STUDY #1 IN A SERIES OF REPORTS ON RADON IN BC HOMES

A MODEL FOR RADON TESTING AND MITIGATION IN AFFORDABLE HOUSING

JUNE 2016

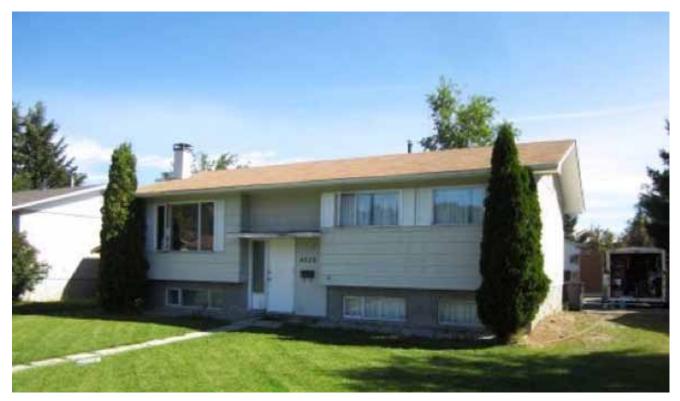
Figure 1. AHSPG House with Basement

All of the 136 AHSPG houses in the study are located within the City of PG. Most of the houses are single family detached dwellings with full basements as shown in Figures 1, 2, 3 and 4. The average age of house in the study was 49 years, with most houses constructed in the 1970s. Most of the people and families living in the houses are considered long-term tenants. In other words, these houses are truly 'home' to many people.

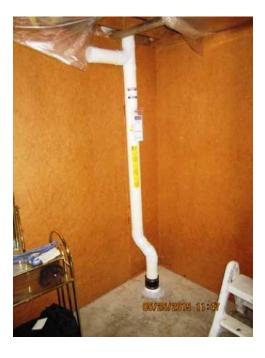
Figure 5. Radon Vent Pipe through Sub-slab

An ASDS reduces the amount of radon entering a home by enabling its evacuation from below the sub-slab via a pipe. This pipe typically extends from the sub-slab (Figure 5), and out the roof, or via a side-wall as shown in Figure 6. Attached to the pipe is an electrically powered fan (as seen in Figure 6) that helps to increase the draw of soil gases from below the foundation and out the pipe.
